# Manhole Inspection Summary

Manhole # **S25C\_\_010MH**

Insp Date: **8/3/07 9:40 AM**

**Location** Address: **1207 MULBERRY-SARATOGA**

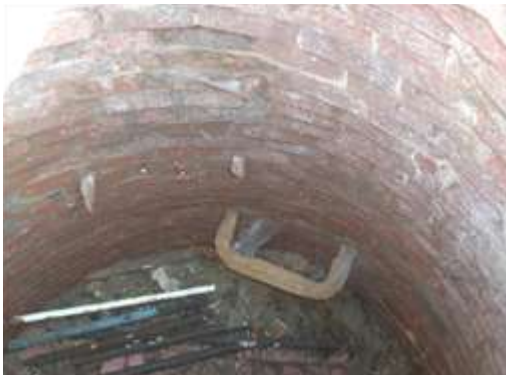
Defect 2

Count: **1** Missing: **3** ☒ **Corroded**

CORRODED AND MISSING STEPS

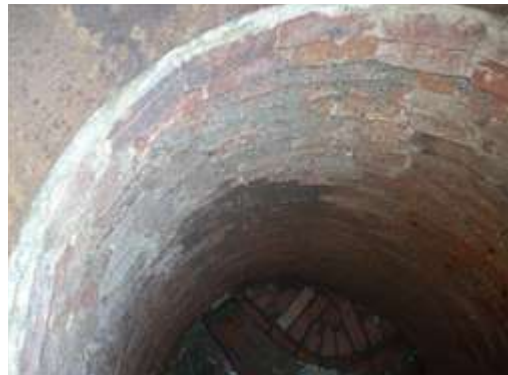
Defect 1

Infiltration: ☐ None ☐ Joint ☐ Cracks ☐ Mortar ☐ Roots ☒ **Wall**

INFILTRATION EVIDENCE ON CORBEL WALL

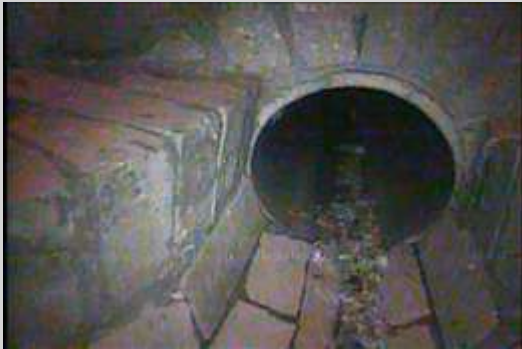
12 O'Clock Outflow

8 in. Circular Gravity Sewer  
Pipe Out @ 12 O'Clock

Pipe Height: **7.2** (in.) Rod and Bar (Angled)  
Pipe Material: **Clay** ☐ Pipe Lined  
Invert Depth: **7.65** (ft.) Flow Characteristics: **Slow**  
Deposits: ☒ None ☐ Mud ☐ Sludge ☐ Debris ☐ Grease  
Silt Depth: (in.) Deposits Extent:  
Infiltration: **None** Pipe Seal Cond: **Sound**

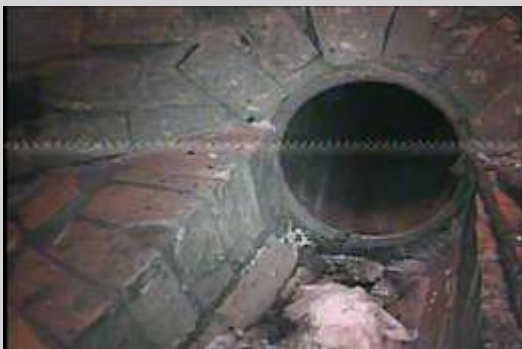
3 O'Clock Inflow

8 in. Circular Gravity Sewer  
Pipe In @ 3 O'Clock

Pipe Height: **8.4** (in.) Rod and Bar (Angled)  
Pipe Material: **Clay** ☐ Pipe Lined  
Invert Depth: **7.25** (ft.) Flow Characteristics: **Slow**  
Deposits: ☒ None ☐ Mud ☐ Sludge ☐ Debris ☐ Grease  
Silt Depth: (in.) Deposits Extent:  
Infiltration: **None** Pipe Seal Cond: **Sound**

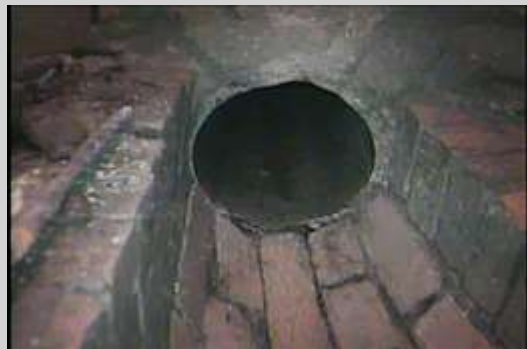
9 O'Clock Inflow

8 in. Circular Gravity Sewer

Pipe In @ 9 O'Clock

Infiltration: **None** Pipe Seal Cond: **Sound**
